# Potential Steering Hardline Contact with Engine Oil Cooler

**Product:** Reelmaster® 5010 Series

**April 20, 2017**

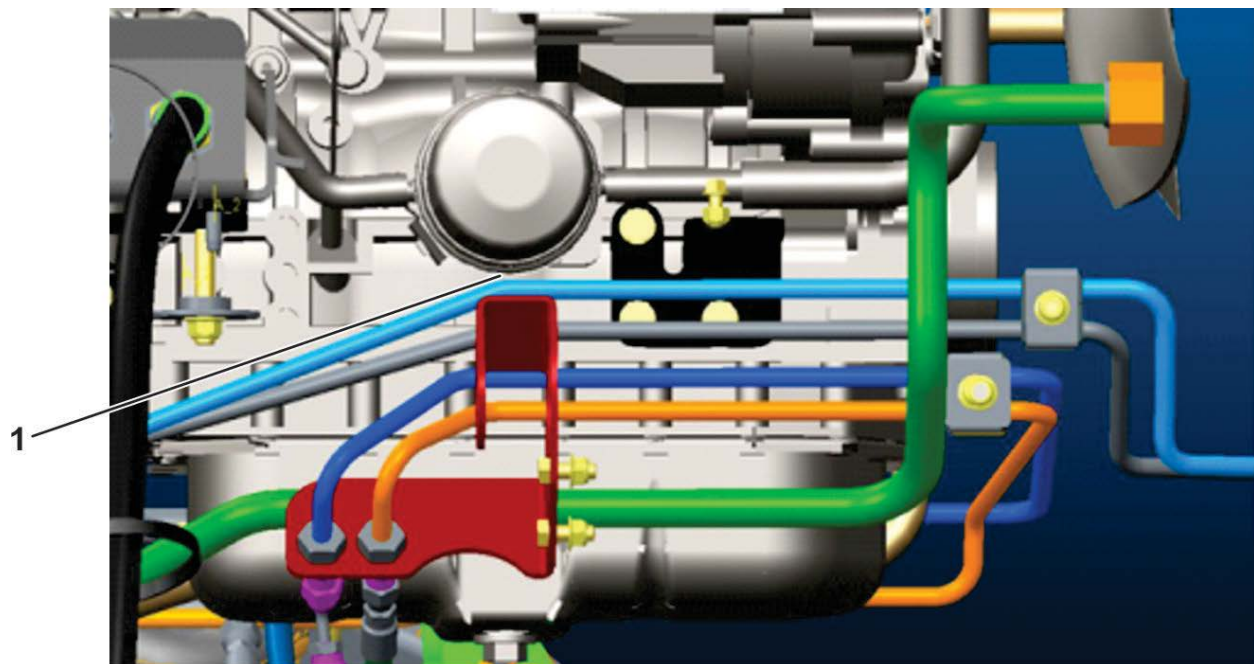
**Figure 1**

A steering hard line could contact the bottom of the engine oil cooler. If this contact continues, over time the steering hard line will wear and may ultimately fail.

1. Area to check for adequate clearance ( $\frac{1}{4}$ " or 6 mm) between hard line and cooler.

During maintenance, inspect the area near the engine oil filter/cooler to ensure there is ample clearance between the cooler and the steering hard line. If the hard line is contacting the engine oil cooler, bend the line down, away from the cooler until it clears. Inspect the hard line for any damage that could result in failure.
