EdgeSeries Reel & EdgeMax Bedknife Damage

Product: Reelmaster® Cutting Units

October 16, 2018

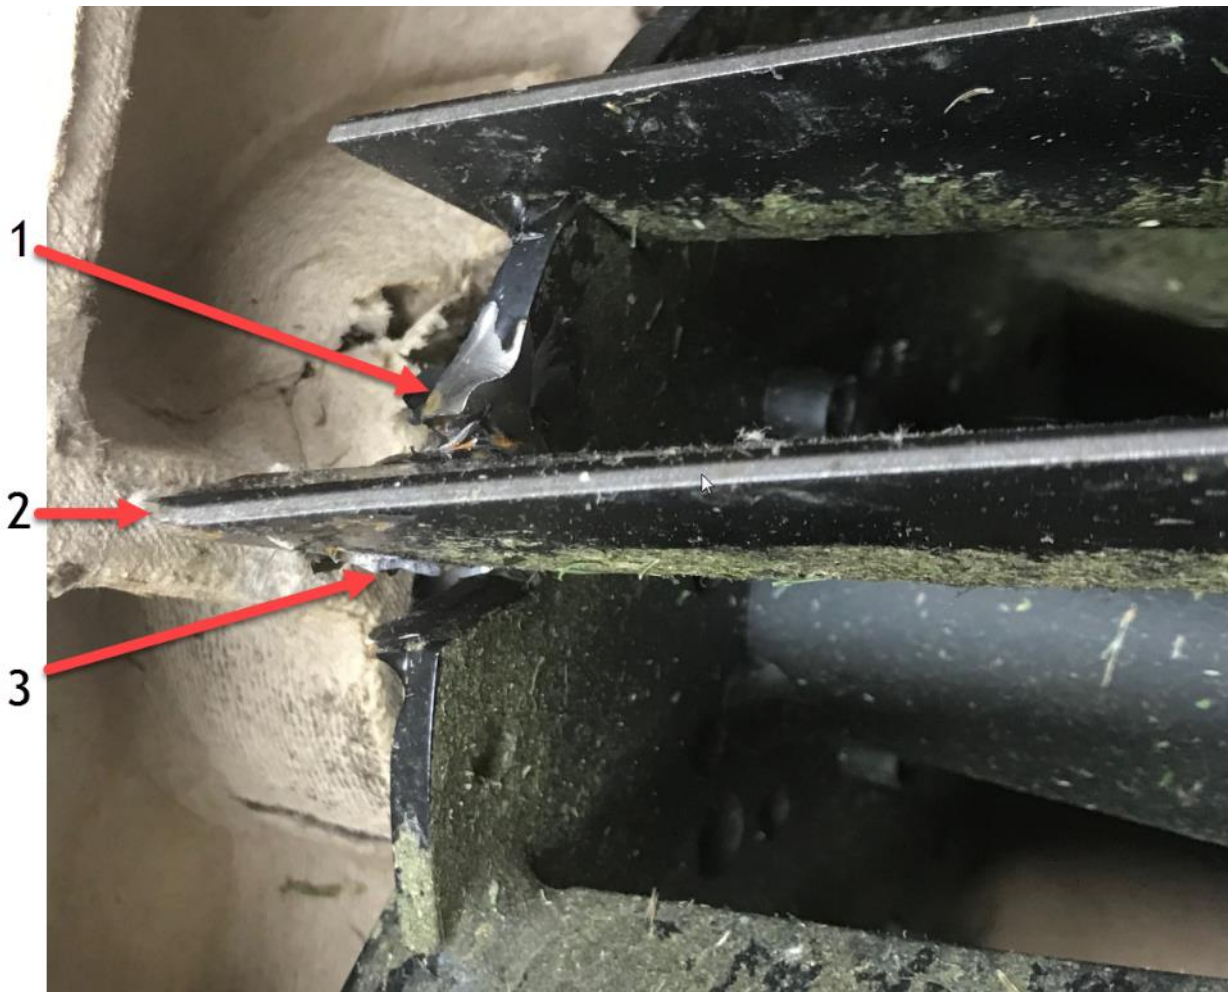
Figure 1

EdgeSeries Reels: Our investigation revealed that Forward Swept Reels (FSR) are more susceptible to damage when contacting foreign objects. Contact will create a condition where the bedknife is forced into the reel while turning, causing damage to the reel blades, weldments and bedknife. The EdgeSeries FSRs have a more aggressive blade angle, which provides better edge retention but also makes it more likely that the reel could catch on the bedknife if there is contact with foreign objects.

- 1 - Spider yielded
- 2 - End of reel blade is bent
- 3 - Weld is torn

This figure shows typical damage from the leading edge of the reel catching on the bed knife. The spider gets pushed back because the reel stops so quickly.

1. Verify proper reel and bedknife maintenance as outlined in the Operator's Manual
2. A lead-in chamfer is required to help prevent damage to bedknife and/or reel. Refer to the Operator's Manual and Figure 5 for more details.

4. The operator must understand where the reel damage occurred on the golf course (steel drainage grates or yardage marker, sprinkler heads, tree roots, loose bolts, angle of mowing, etc.), and try to reduce the chances for impact. For instance, lower the sprinkler head, cut tree root out, or change approach angle to mitigate contact, etc.

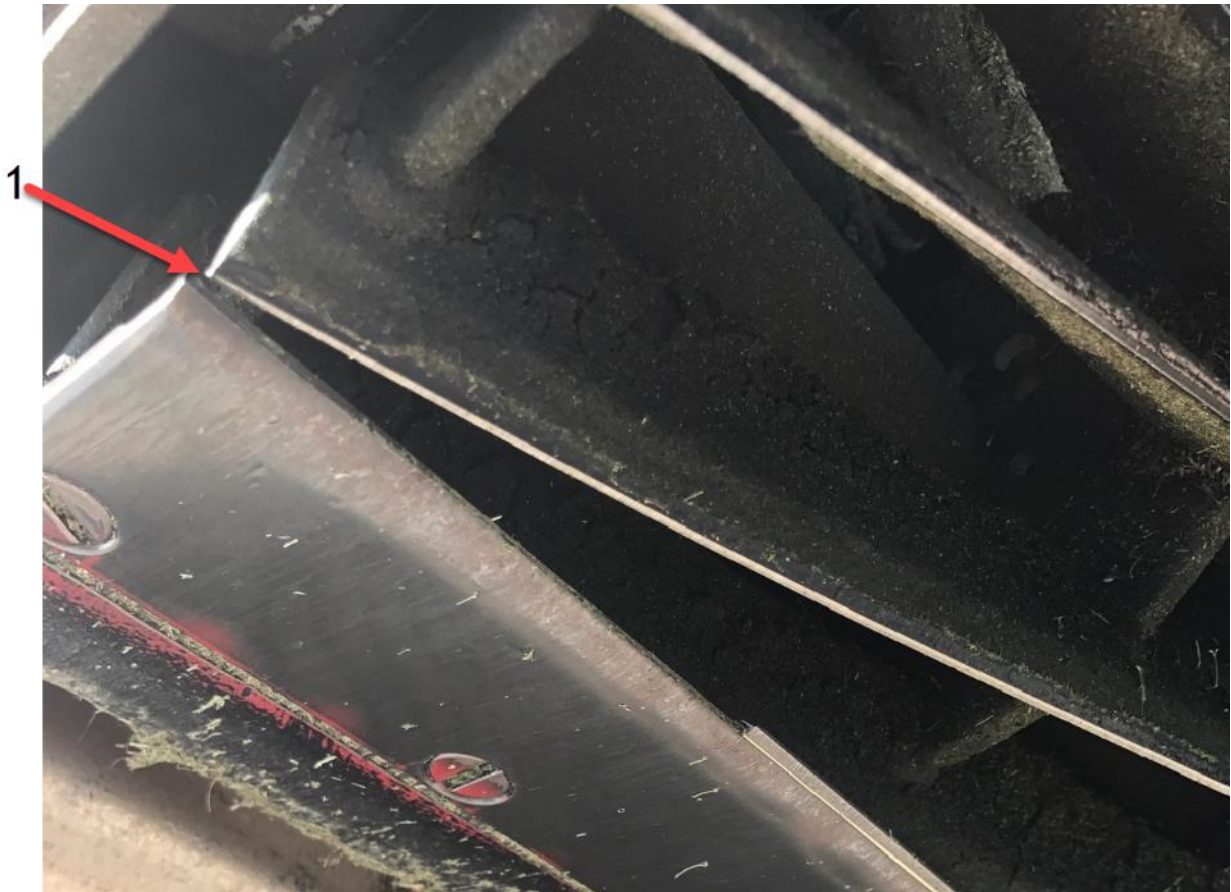
Figure 2

For EdgeMax bedknife damage, inspect for proper cutting unit maintenance and adjustment. If the bedknife is bent at all, the insert will fracture because the tool steel insert does not bend. Additional considerations:

1 - Typical Bedknife Damage

This figure shows the insert has been pulled out of the knife from the impact with the reel. The bedknife may be bent upward and inward as well.

1. Inspect for signs of impact and address impact conditions as listed above
2. Foreign material such as debris, golf balls, machine hardware, etc. should always be cleared before mowing
3. Ensure proper grind angles are being used. Refer to the grind angle chart on [Bedknives Reference Chart](#)
4. Worn bedknives will eventually weaken the insert joint. Measure the bedknife wear per [Toro | Reel Mower Sharpening Guidelines](#) and [Bedknives Reference Chart See Figure 4](#)

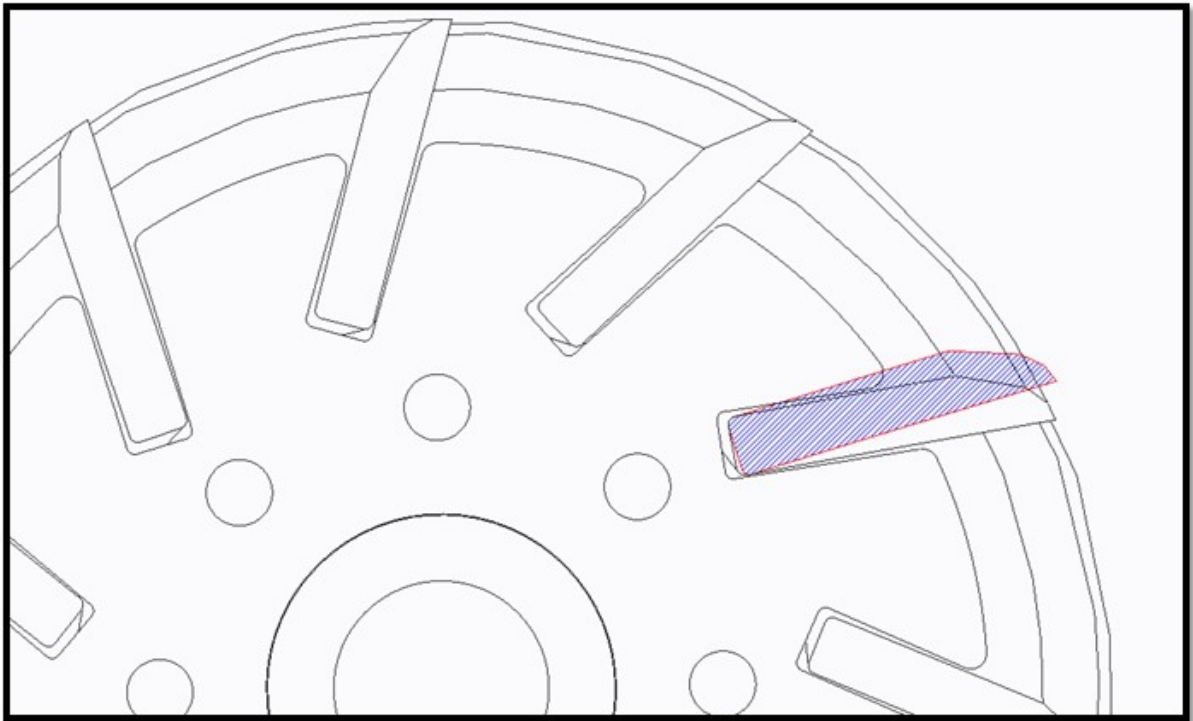
3. The FSR design is more prone to damage since the reel outside diameter "grows" during impact conditions versus the radial reel design, and thus having a lead-in chamfer is more important. See Figure 3

This image shows how the reel grows if a blade is bent back on a forward swept reel

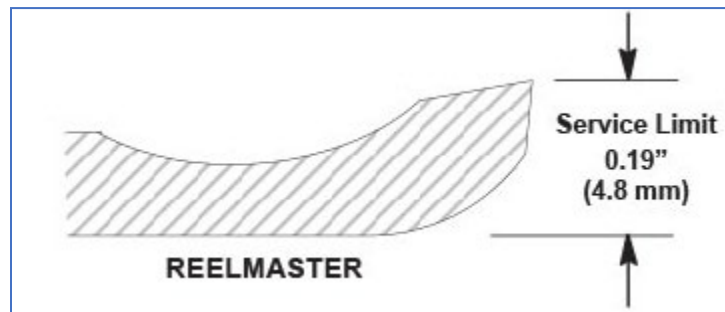
Figure 4

Measuring Bedknife service limit

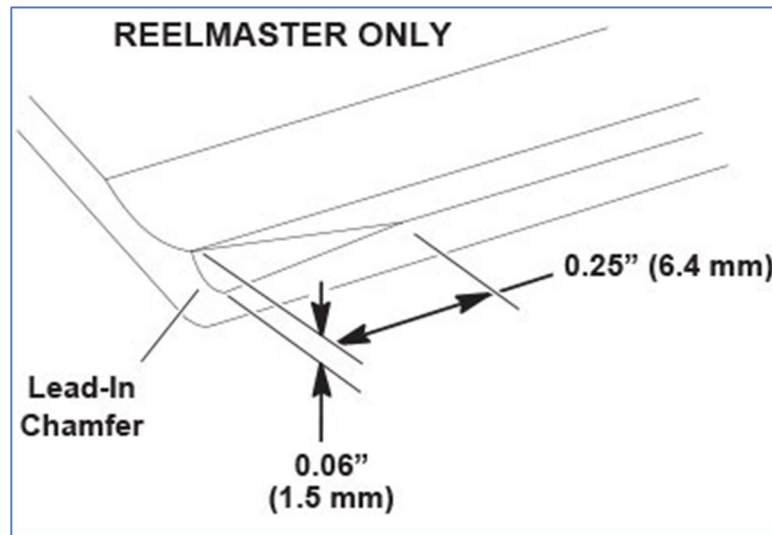
Figure 5

Notice the lead in chamfer on the leading edge of the bedknife. The lead-in chamfer helps to ensure the reel blade is forced over the bedknife even if the knife is deflected up slightly.
