Customer Bulletin

January 22, 2020

Groomer Drive Direction Knob Falls Off Universal Groomer Drive (Greens)

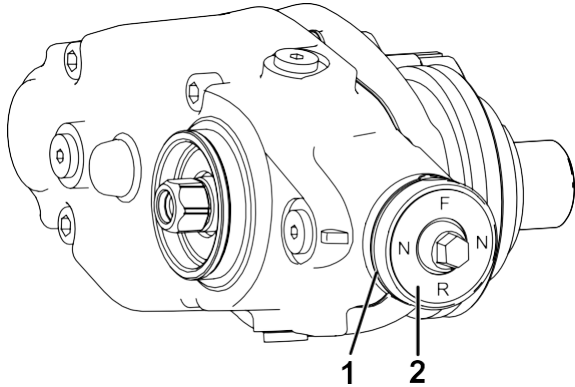
The sun's ultraviolet rays can cause the O-ring on the groomer-direction drive knob to deteriorate, which allows the set pin and knob to fall off of the groomer-drive housing.

- 1. O-ring
- 2. Knob

If the O-ring deteriorates, install the Groomer Knob Kit (Part No. 137-0959), which includes a new groomer-drive knob and hex-socket bolt. Refer to your authorized Toro distributor for more information.
