Customer Bulletin

January 23, 2020

Groomer Drive Direction Knob Falls Off

Universal Groomer Drive (Fairway)

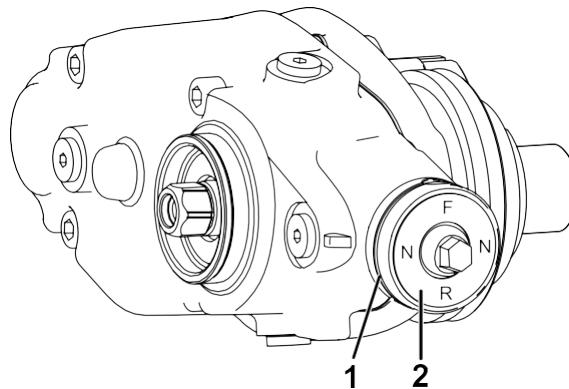
The sun's ultraviolet rays can cause the O-ring on the groomer-direction drive knob to deteriorate, which allows the set pin and knob to fall off of the groomer-drive housing.

1. O-ring

2. Knob

If the O-ring deteriorates, install the Groomer Knob Kit (Part No. 137-0959), which includes a new groomer-drive knob and hex-socket bolt. Refer to your authorized Toro distributor for more information.
