Customer Service Bulletin Commercial Business Group

Greensmaster 3200/3200-D[®]

<u>UNITS AFFECTED:</u>	<u>MODEL NUMBER:</u>	<u>SERIAL NUMBERS:</u>
	04380	60001-70184
	04381	60001-70743

Subject: Traction Pump Shaft Seal leakage.

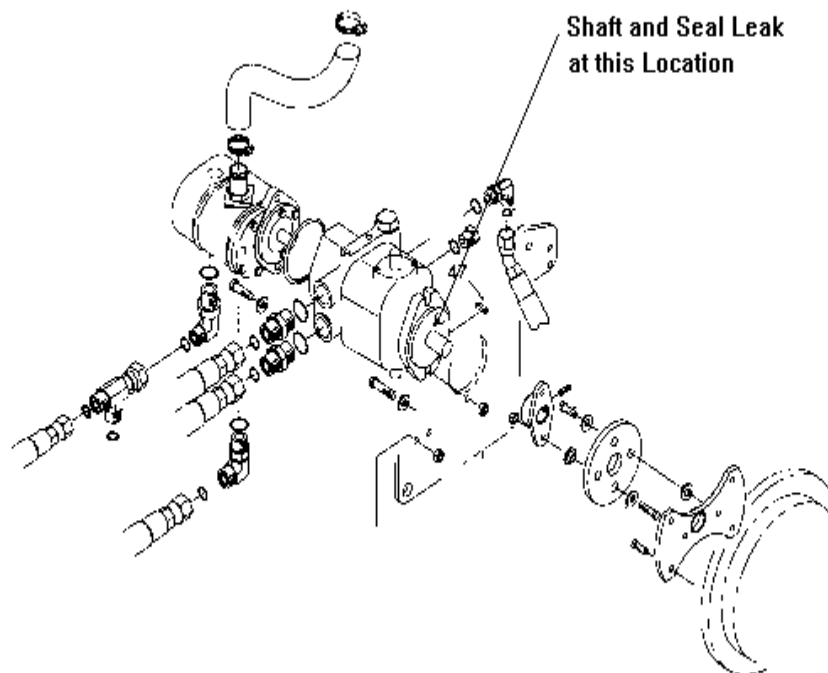
The traction Piston Pump (93-2586) may exhibit a hydraulic oil leak at the Input Shaft Seal within 500 hours of operation, due to a spiral mark in the shaft surface (marks may not be visible unless magnified). Attempts at repairing the leak with a new seal may result in a repeat leak. A replacement shaft is required to correct the issue.

If your unit exhibits this issue, contact your local Toro distributor for an inspection and repair to correct the problem.
