# Customer Service Bulletin

### Greensmaster<sup>®</sup> 3200-D

<u>Model/Serial Range:</u>	<u>Model Number:</u>	<u>Serial Numbers :</u>
	04381	50001-90400
	04381	90901-91086

**Subject: NEUTRAL RETURN SPRING PIN REWORK**

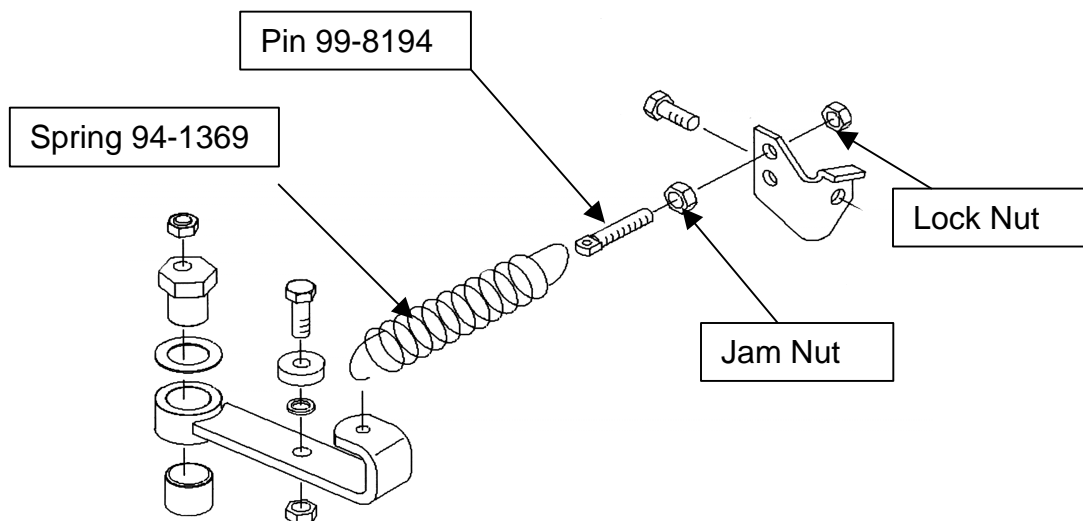
The Pin that connects the neutral Spring to the frame, may wear through. If the pin wears through, the transmission will not automatically return to neutral and could result in personal injury, equipment damage or turf damage.

Replace the parts (Spring and Pin) identified below. These parts are located on the top of the transmission. Best access for the Locknut is with a deep well socket wrench and extension inserted over the top surface of the muffler. Allow muffler to cool.

1. Replace Spring (94-1369) and Pin (99-8194). Position jam nut at similar position on new pin so spring tension does not change.
2. Test unit to ensure neutral return mechanism works correctly. If neutral adjustment is required, follow printed instructions found in appropriate Toro operators manual.
