Customer Service Bulletin Commercial Business Group

Groundsmaster® 300 Series

Subject: Availability of repair parts to correct PTO Support Plate frame damage

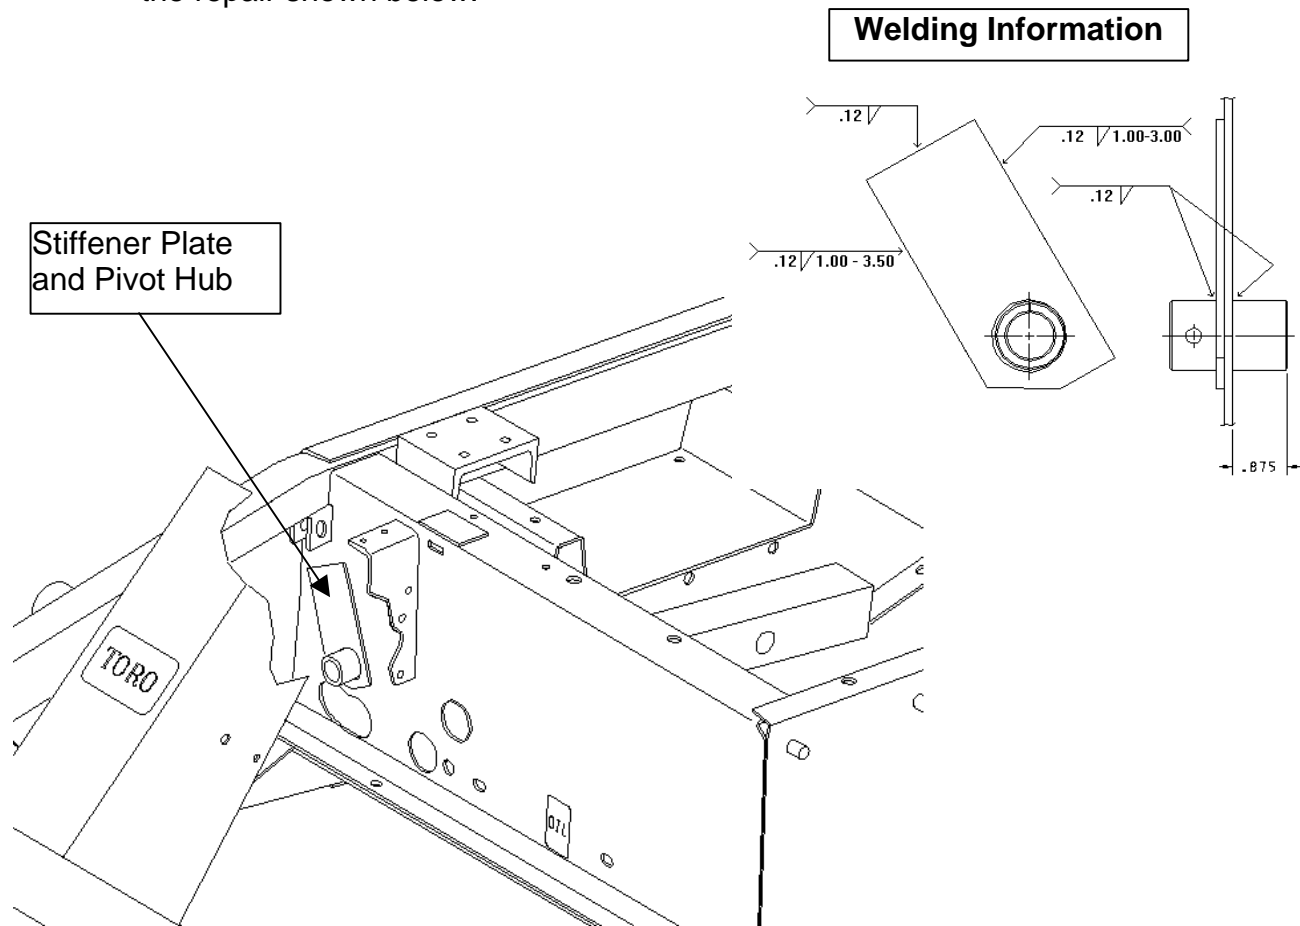
A cracked PTO Support Plate is caused by repeated impacts against solid objects, such as tree roots or substantial loose debris. This damage can usually be repaired by welding the visible cracks. If the shaft support area is broken out, replacement parts are available to repair and reinforce the affected frame area.

One Pivot Hub 21-1210 and one Stiffener Plate 94-6870 are required to perform the repair shown below.
