Customer Service Bulletin Commercial Business Group

Aerator 686

<u>Model/Serial Range:</u>	<u>Model Number:</u>	<u>Serial Numbers:</u>
	44850	20100-40200
	Olathe 686	00000-99999

Subject: Main Frame Pivot Pipe damage.

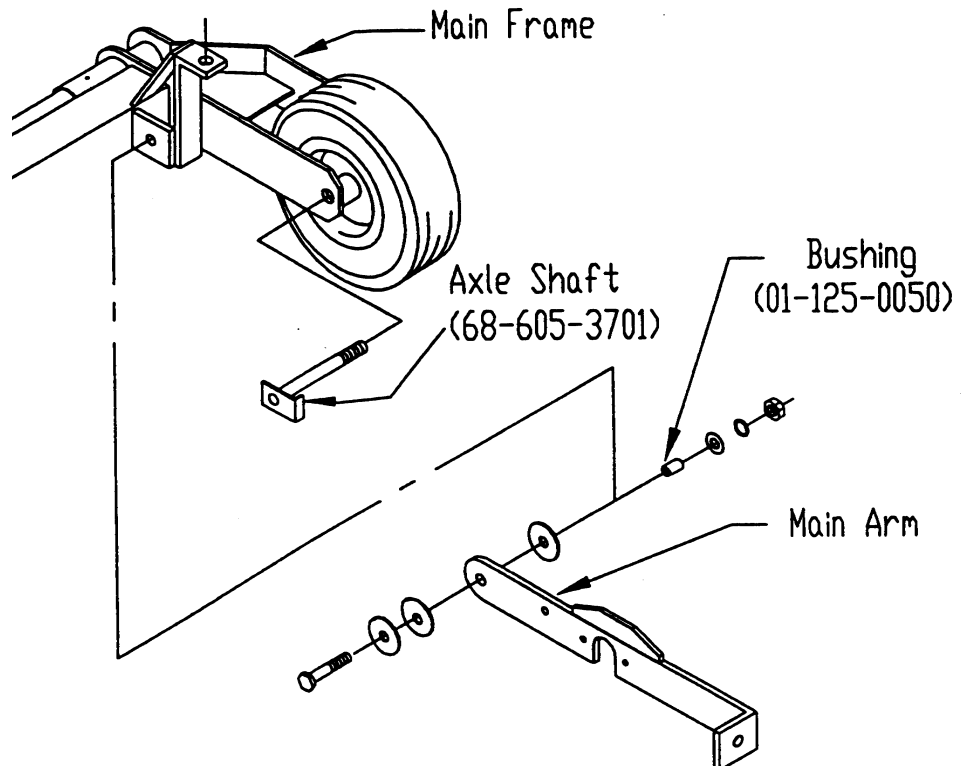
If the Main Arm Bolts are loose or the bushings are worn, the Coring Gang Assembly will move side-to-side and contact the Axle Bolt of the Main Frame Wheel. Should the hand pump be operated to lift the aerator while the Coring Gang Assembly is in contact with the Axle Bolt, the forces generated will begin to twist the Main Frame Pivot Pipe. It is possible to damage the frame to where one wheel can be as much as 8 inches (200 mm) higher than the other.

To increase the clearance and reduce the chance of contact, the original bolt may be replaced by Axle Shaft (68-605-3701). The replacement Axle Shaft eliminates the hex head of the original bolt as shown in the illustration below. Parts are available through your local Toro distributor.
