Customer Service Bulletin Commercial Business Group

Workman[®] 3000/4000 Series

Subject: Rear Wheels May Loosen.

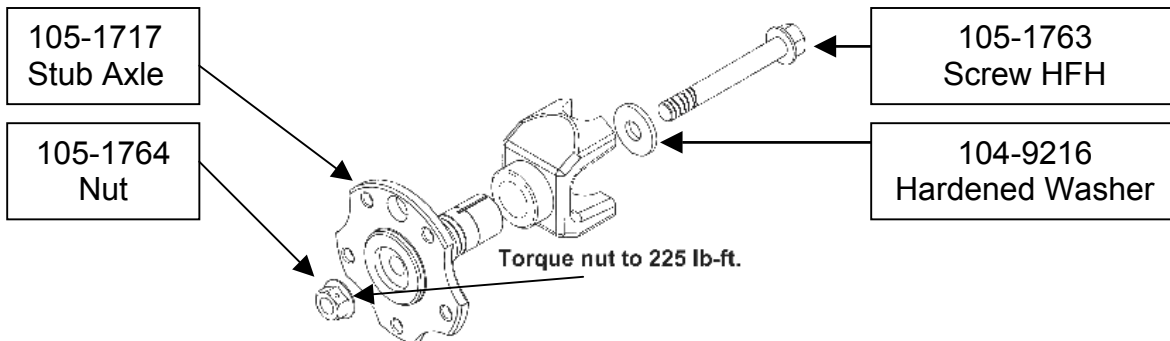
Some rear wheels have been found to loosen at the Stub Axle (93-7090-03). The Flange Lock Nuts (32128-53) can become loose through normal operation of the vehicle. This condition can allow the Stub Axle and wheel assembly to come loose from the End Yoke (92-4190) of the Driveshaft Assembly (98-2918).

Stub Axle	105-1717
Screw- HFH	105-1763
Nut	105-1764
Hardened Washer	104-9216.

When installing these parts, torque the bolt/nut assembly to 225 ft.lbs (305 Nm)* with the Nut located on the wheel side of the Stub Axle assembly. This improved Stub Axle Assembly is currently available through your local Toro Commercial Products Distributor, one of each part specified is required per rear wheel on the 3000/4000 Series Workman vehicle.

* Caution: Many air impact wrenches do not exceed 100 ft.lbs.(136 Nm) torque capacity.
