Customer Service Bulletin

All machines with Kubota D1105 and D1105-T engines.

SUBJECT: Vibration in Traction Units with Kubota D1105 series engines.

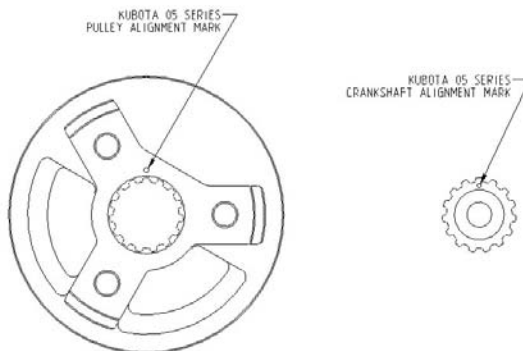
SITUATION: There are various factors that may induce vibration in the D1105 engines, such as broken motor mounts, bent pulleys, and loose fasteners. The engine is externally balanced by the Fan Drive Pulley.

CORRECTION: When investigating vibration issues on products with a Kubota D1105 Series engine, start by checking the following components: motor mounts, fasteners, belt condition, pulleys, driveshaft, and coupler. The alignment of the Fan Drive Pulley (crankshaft pulley) to the front of the crankshaft (gear case side) should be inspected only after checking all external factors first. Remove the bolt and verify that the marks are in alignment. If after inspecting, the marks are found to be out of alignment, realign them. Then, retorque crankshaft end bolt to the Kubota Service Manual specifications listed in the table below. If you have questions regarding this issue, contact your Toro Distributor.

TIGHTENING TORQUES FOR CRANKSHAFT END BOLT
