Customer Service Bulletin Commercial Business Group

Greensmaster® 3150 and 3250-D

Date: November 21, 2003

Subject: No Reel Drive Due to Loose Cutting Unit Spline Nut.

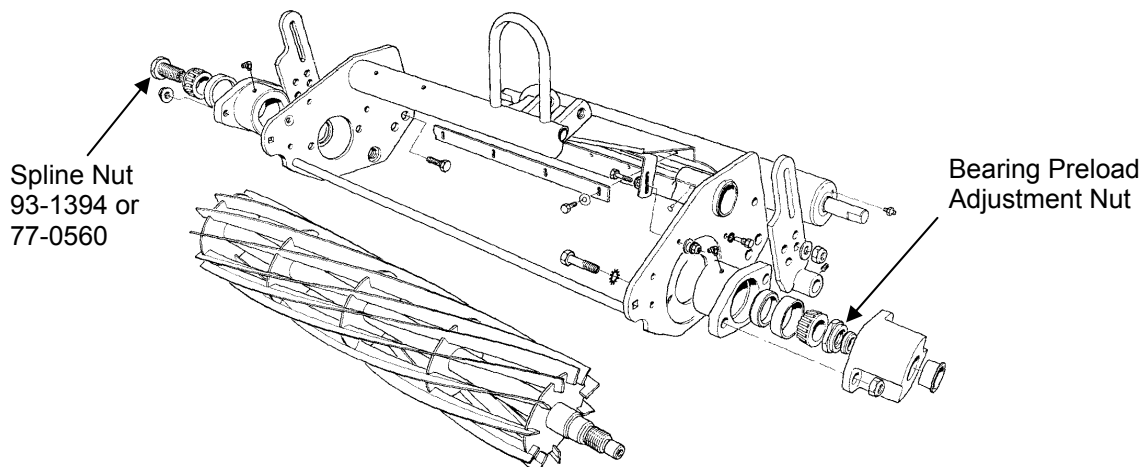
The standard cutting unit Spline Nut (93-1394) and groomer Spline Nut (77-0560) may not remain tight to the reel shaft due to pressure spikes in the hydraulic system. Standard Spline Nut (93-1394) is used in all cutting units equipped with tapered reel bearings, such as Model 04404, 04406, 04408, 04450, and 04468 cutting units. Groomer Spline Nut (77-0560) is used in place of the standard Spline Nut when Groomer Kit (04455) is installed. The repair procedures are the same for both.

1. Loosen the bearing preload adjustment nut at the opposite end of the reel to ensure it will not influence installation of the Spline Nut.
2. Remove the Spline Nut and thoroughly inspect it for damage such as tiny hairline fractures. Replace if necessary.
3. High strength Loctite® 271 threadlocker is used to secure the Spline Nut. Clean and prepare the reel shaft and Spline Nut threads according to the directions on the product container. Apply Loctite 271 as directed. Tighten to 60 ft-lb (80 Nm).

Note: Lower strength Loctite 242 was originally used on these units.

4. Assemble the cutting unit as usual (refer to Service Manual) but do not operate until the Loctite 271 has fully cured.
