Customer Service Bulletin Commercial Business Group

Multi Pro[®] 1200 and 1250

Date: August 11, 2004

Subject: A capped vent may cause leaking.

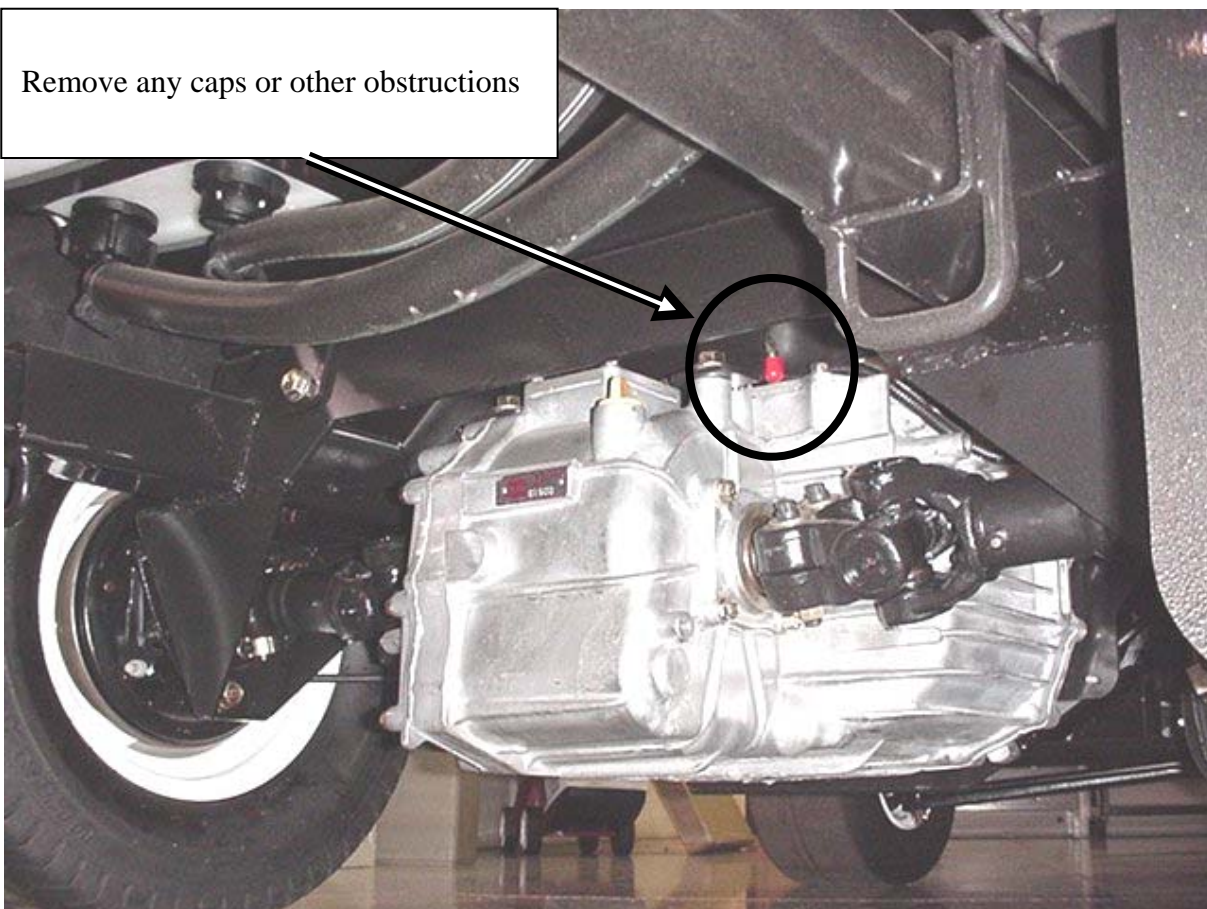
The transaxle used on the Multi Pro 1200 and 1250 sprayers is vented to atmosphere through a tube found at the right rear of the transaxle. During assembly this vent is capped for purposes of cleanliness. The cap installed during assembly may have been left in place which would plug the vent during operation. Leaks may result due to excessive pressures caused by a plugged vent.

During service or maintenance of the affected units check for and remove caps or any other obstruction that may impede venting.
