Customer Service Bulletin Commercial Business Group

Workman[®] 3000/4000 Vehicles

Date: August 17, 2005

Subject: Possible missing weld at floor plate below clutch pedal.

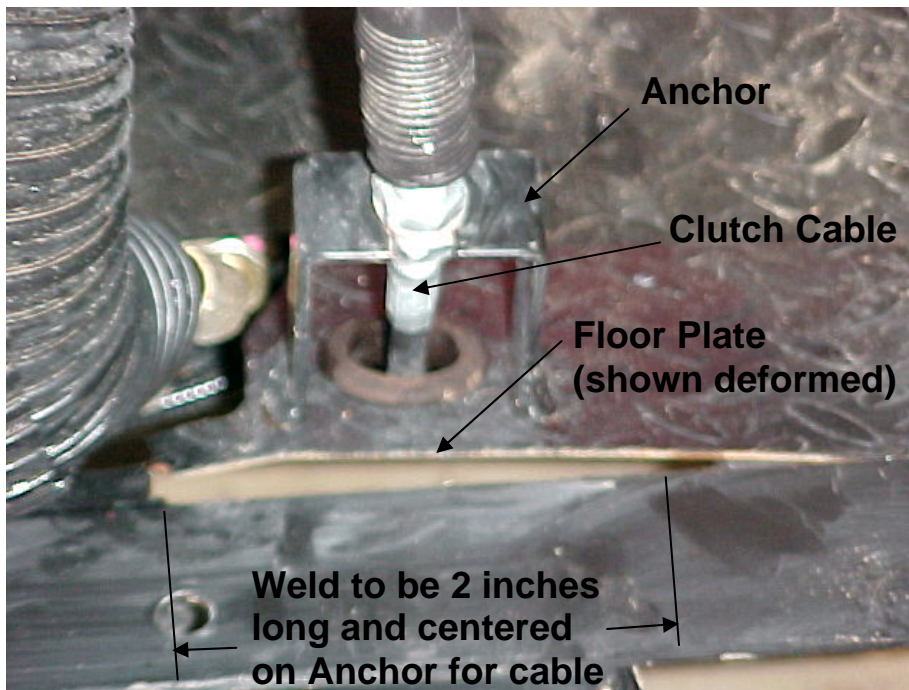
The floor plate may be missing a weld just forward of the stationary anchor point for the clutch cable. If this weld is missing, the clutch engage forces may eventually deform the floor plate upwards and change the operation of the clutch.

Inspect the unit for the condition pictured below or a missing weld in the area identified. If the area is deformed or the weld is missing, contact your local Toro Commercial Products Distributor to arrange for repair.
