Customer Service Bulletin Commercial Business Group

Date: January 24, 2006

Subject: Oil Leak at the Rear 4WD Axle Wheel Ends

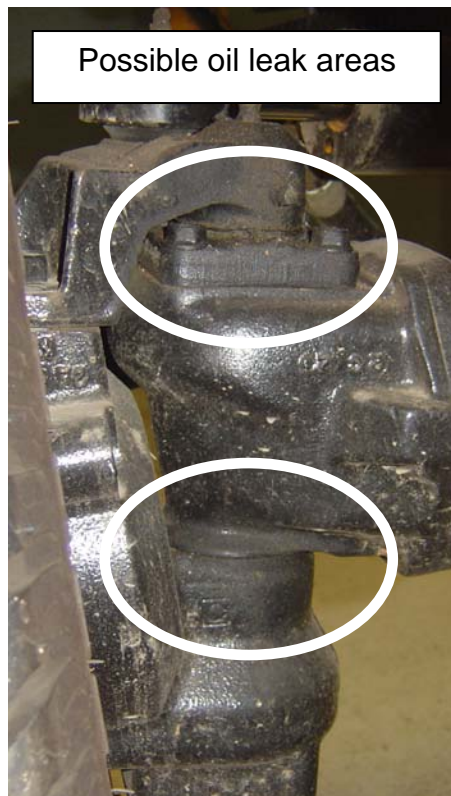
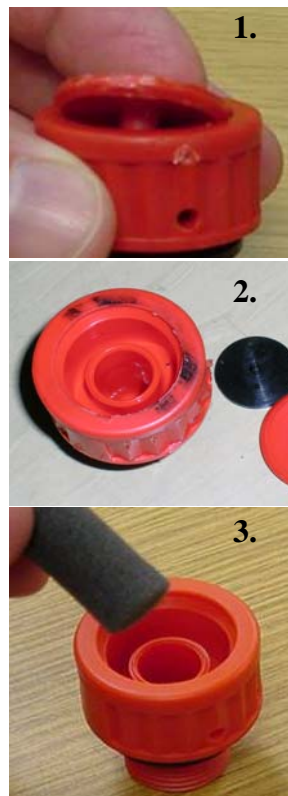
Some 4WD machines may exhibit an oil leak at one or both wheel ends of the rear axle. This leak will appear as a slight weeping at the upper pivot area and/or lower pivot area of the final drives (see picture). This situation is created by the Vent that can allow a slight pressure to build inside the axle housing (from temperatures generated during operation). This type of oil leak causes the surrounding surface to become damp and allows dirt and debris to collect. Unless the leak is significant enough to form a drip, periodic cleaning is all that is required.

If a drip forms, the condition can be improved through a minor internal vent modification. Simply pry the top Cap from the Vent and replace the rubber diaphragm with a Foam Insert (110-4815). Snap the top Cap back into place and check that the axle oil level is correct (see Operators Manual).

1. Pry off top Vent Cap.
2. Remove and discard rubber diaphragm.
3. Insert Foam Filter Insert (110-4815).
4. Snap top Vent Cap back into place.
