Brake Drum Contacts Backing Plate

Product: Material Handler 400

April 27, 2011

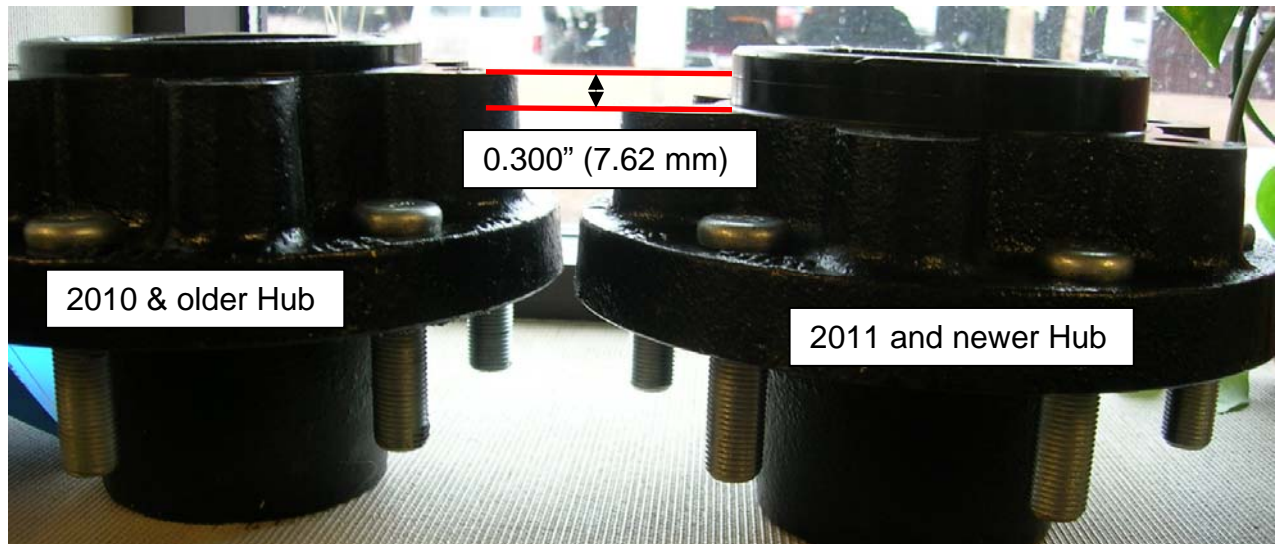
The Brake Drum may contact or rub the Backing Plate when an Electric Brake Kit (44942 or 44943) is installed on a pre-2011 model Toro or TyCrop MH 400. As an ongoing product improvement to the braking system of the Material Handler 400, new electric brakes and wheel hubs were incorporated starting with 2011 production. This change may affect the pre-2011 units after installing either Electric Brake Kit (44942 or 44943) due to the difference in the Hub dimensions. The 0.300" (7.62 mm) hub height difference may cause the installed Brake Drum to contact the Backing Plate, causing a scrubbing sound as the wheel is rotated.

For each position that will have a new brake assembly installed, either replace each older-style Hub with Hub (T54031039) or have the old-style Hub machined to remove the extra height. Machining may not be the most economical choice.
