Service Part Throttle Cable Is Too Short

Product: Groundsmaster 3280-D

May 31, 2011

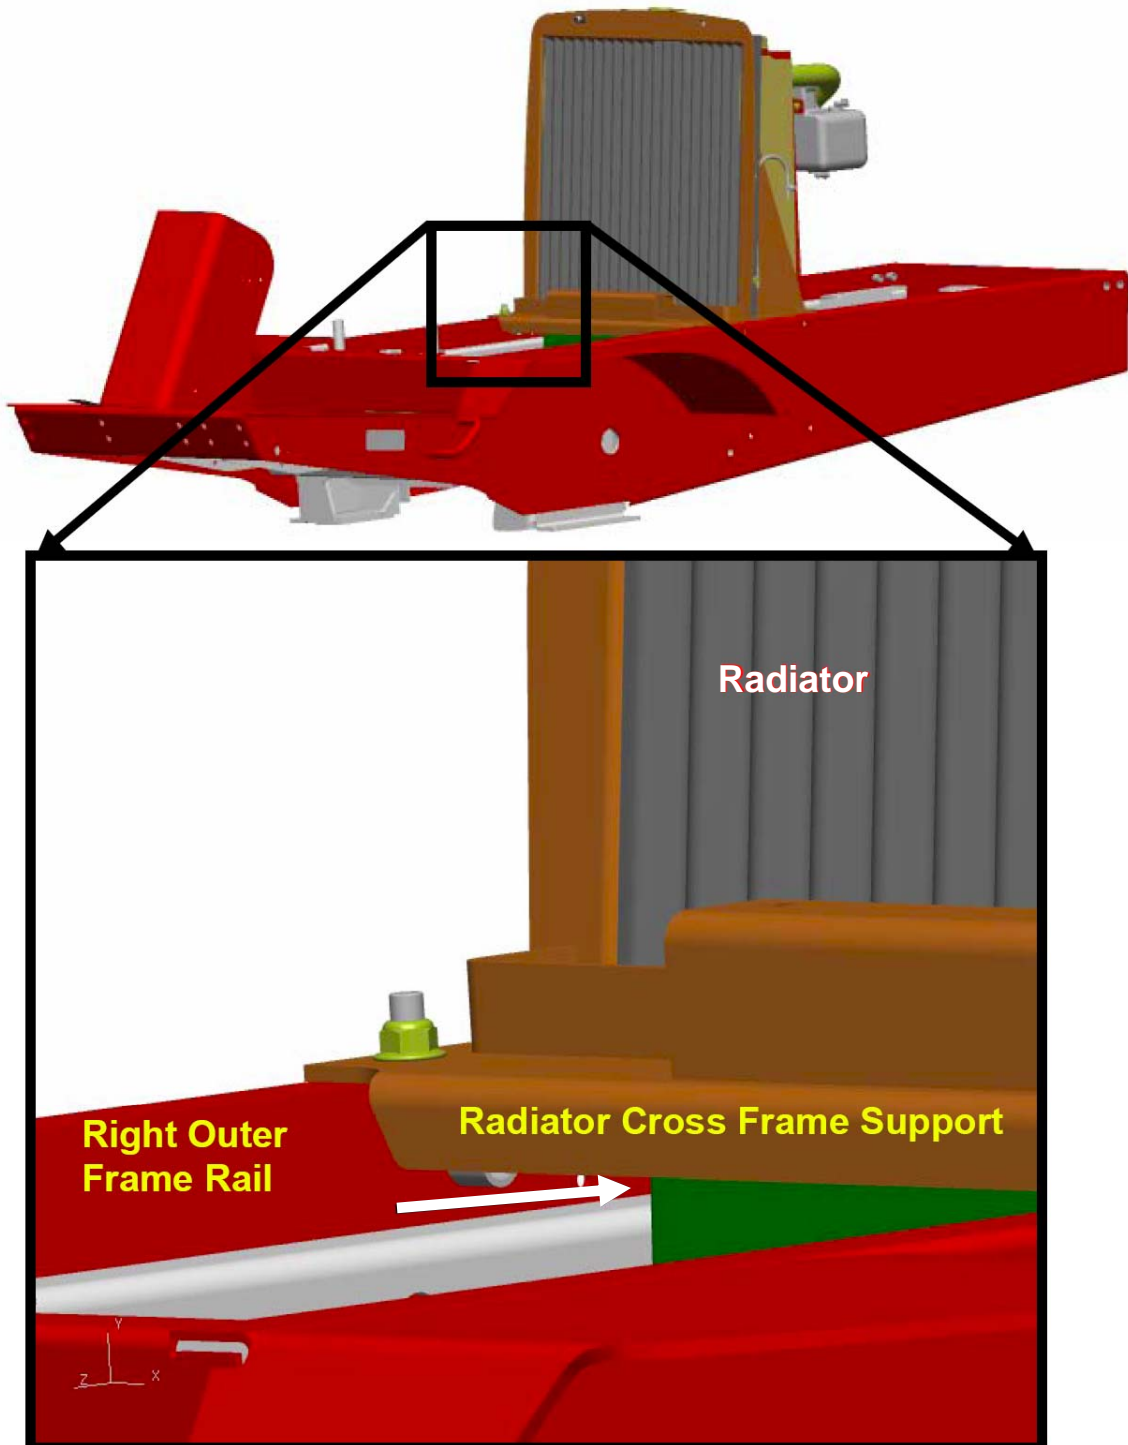
Installation Diagram for Service Part Throttle Cable

Throttle Cable ([108-2033](#)) originally installed in Groundsmaster 3280-D 3320 has become obsolete as of late 2009 production. This part number has been cross-referenced to Throttle Cable ([117-0824](#)). This new cable is approximately 2.3" (58 mm) shorter than 108-2033; it requires different routing as it runs past the right side of the radiator leading back to the engine.

Route Throttle Cable (117-0824) through the opening just below the Radiator support and above the inner right side frame channel (gray colored in this image) back to the engine compartment.
