Unable To Maintain Adjusted Coring Depth

Product: Pro Core® 864/1298

Jan 12, 2012

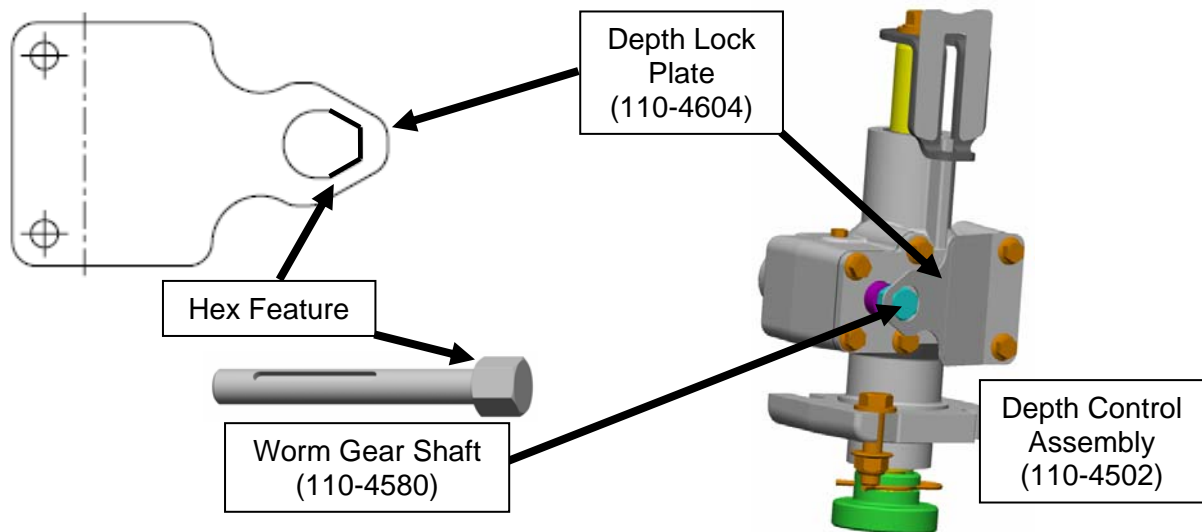
Wear in the hex feature area of Depth Control Assembly (110-4502) and Worm Gear Shaft (110-4580) can cause loss of the depth setting on both 3 point Pro Core aerators.

Replace Depth Lock Plate. Verify that the replaced Depth Lock Plate has firm contact with the hex feature of Worm Gear Shaft. Inspect Worm Gear Shaft for wear or “rounding” of the hex feature that mates with Depth Lock Plate; wear in that area will contribute to the depth control slipping condition and may require the replacement of worm Gear Shaft.

We suggest that you inspect these areas for wear prior to each season’s use of your Pro Core aerator to maintain reliable control of the adjusted coring depth.
