Ignition Switch Malfunction Causes Multiple Symptoms

Product: Groundsmaster® 360

April 27, 2012

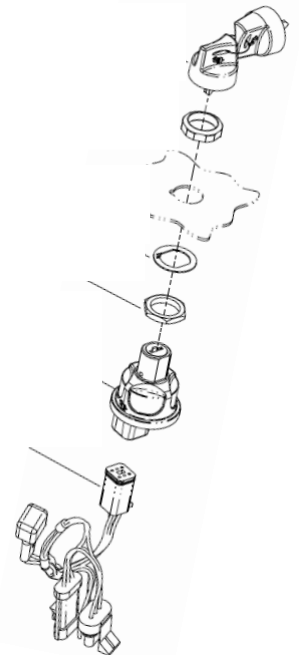
Several electrical issues have been found to be caused by malfunction of factory-installed Ignition Switch ASM, including:

- Constant or intermittent failure of factory-installed Ignition Switch ASM
- Unintentional engagement of the engine starter or starter overheat/failure while key switch is in the Run position
- Intermittent flickering of glow plug and/or diagnostic lights
- Failure of Stop Solenoid
- Damage/overheating of Wire Harness

If any of the above referenced conditions are experienced, the factory-installed Ignition Switch Assembly must be replaced with updated Ignition Switch ASM (121-5357) to correct the issue.
