4 Wheel Driveline Binds/Difficult Steering

Product: Workman HDX Series

May 10, 2013

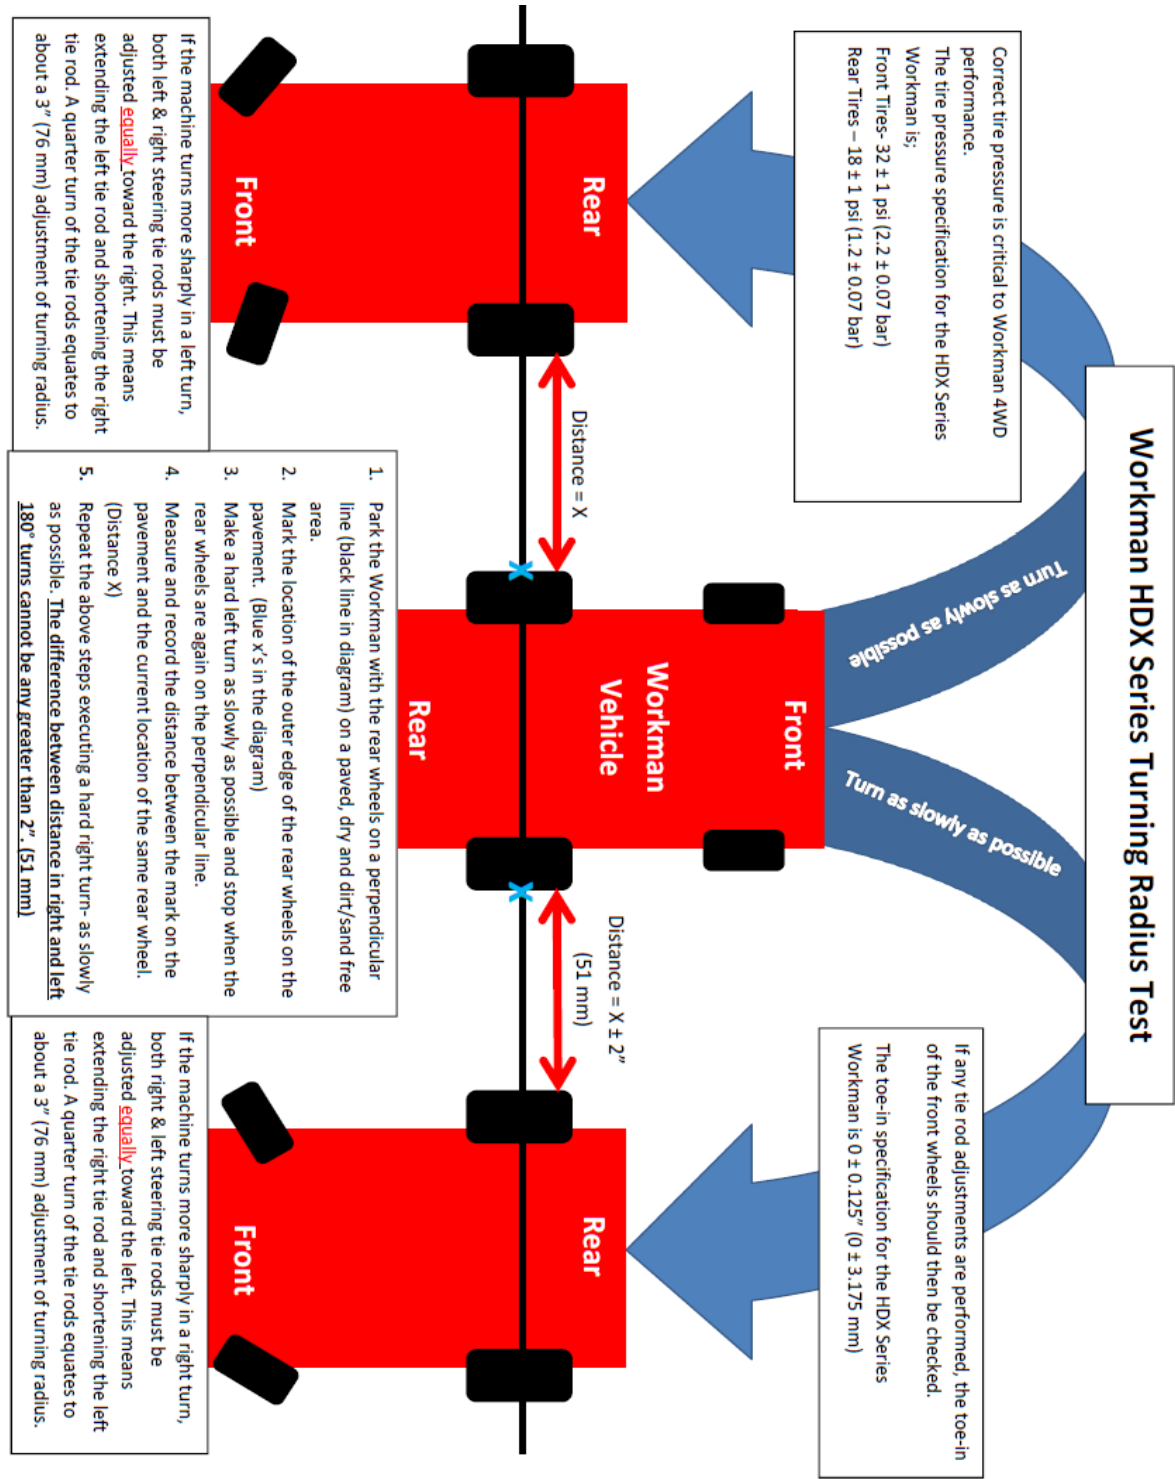
4 Wheel Driveline Binds/Difficult Steering

Popping or grinding sounds coming from either the front or rear differential in 4WD Workman vehicles have been reported in 4WD machines built between 2009 and 2013. Other related observations include difficulty in steering, front or rear tires dragging, and general traction bind. The issue only occurs when the vehicle is operated on dry pavement in specific maneuvers: switching vehicle from backward to forward travel and in slow extreme turning situations. (i.e., trailer backing, etc.) A contributing factor has been determined to be incorrect adjustment of the steering tie rods, resulting in the vehicle turning sharper in one direction, and undesired engagement of 4WD.

In a few units, front CV joint failures have been reported. If steering bias exists, the CV joint can be over extended past its design limit for bend radius in sharp turns.

Turning radius inspection must be performed to determine if adjustment is indicated. See the attached diagram for inspection process, turning radius specifications and adjustment procedure. If replacing the CV axle, inspect the vehicle turning radius performance in full right and left turns after the CV installation, then perform a toe-in evaluation to verify correct adjustment.
