## Loose Steering Valve Retaining Bolts

**Product: Reelmaster® 5010 Products**

**August 7, 2014**

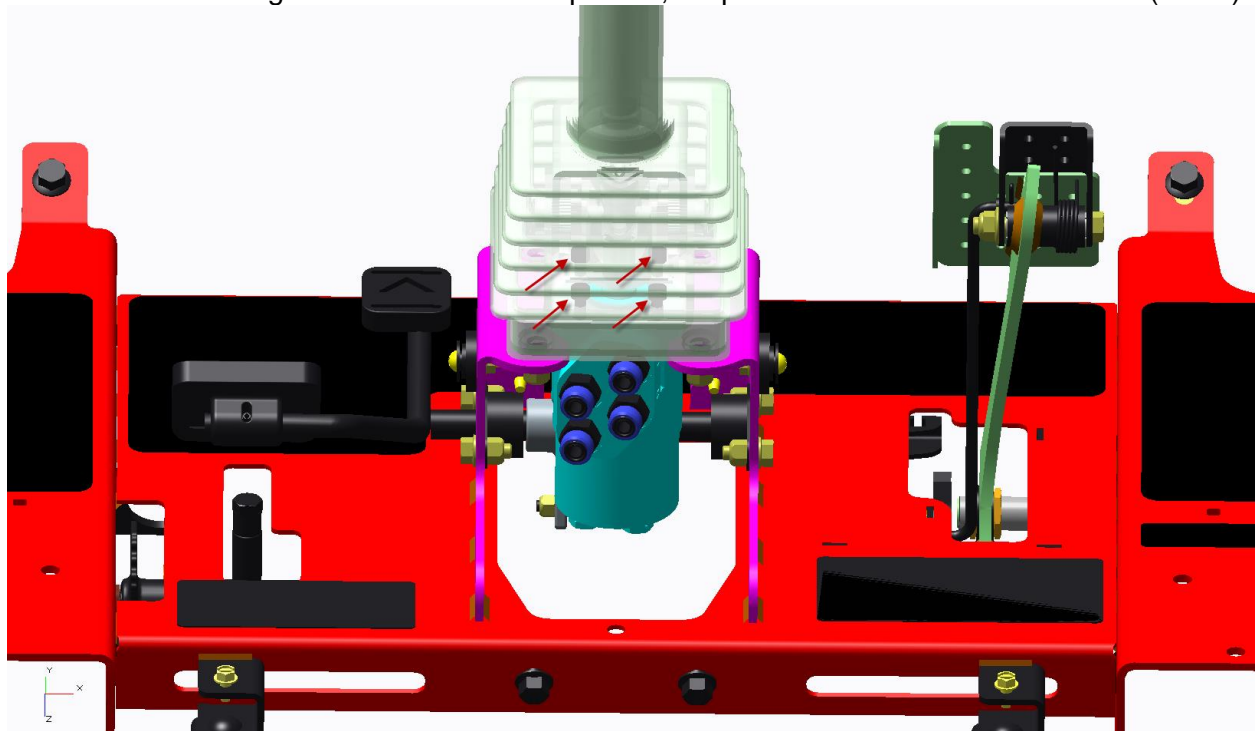
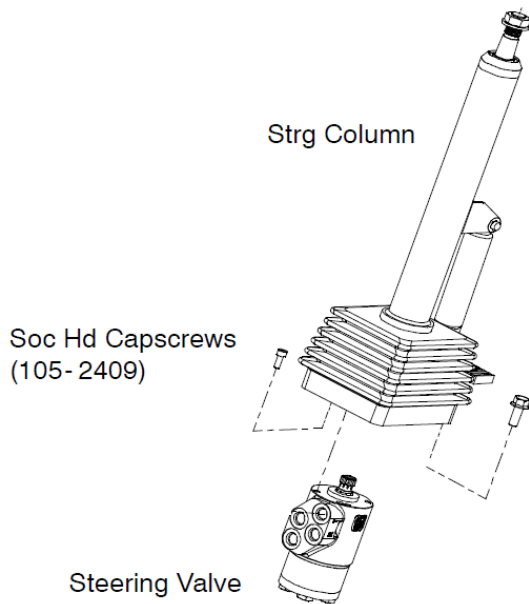
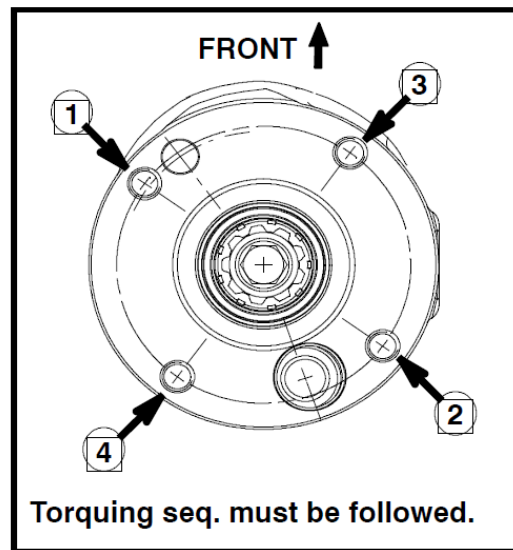
On Reelmaster 5010's built between Jan 1, 2014 and July 30, 2014. The four hex-socket-head cap screws fastening the steering valve to the steering column may not have been tightened to the proper torque specification. The bolts could back out causing the steering valve to separate from the steering column, which could result in a loss of steering. To address this issue, a mandatory product rework has been issued.

5. Lift rubber steering boot. In a criss cross pattern, torque four allen head bolts to 7lb\*ft (9N\*m).
