Replacement Engines Have Different Wiring

Product: Pro Force® Debris Blower

November 12, 2014

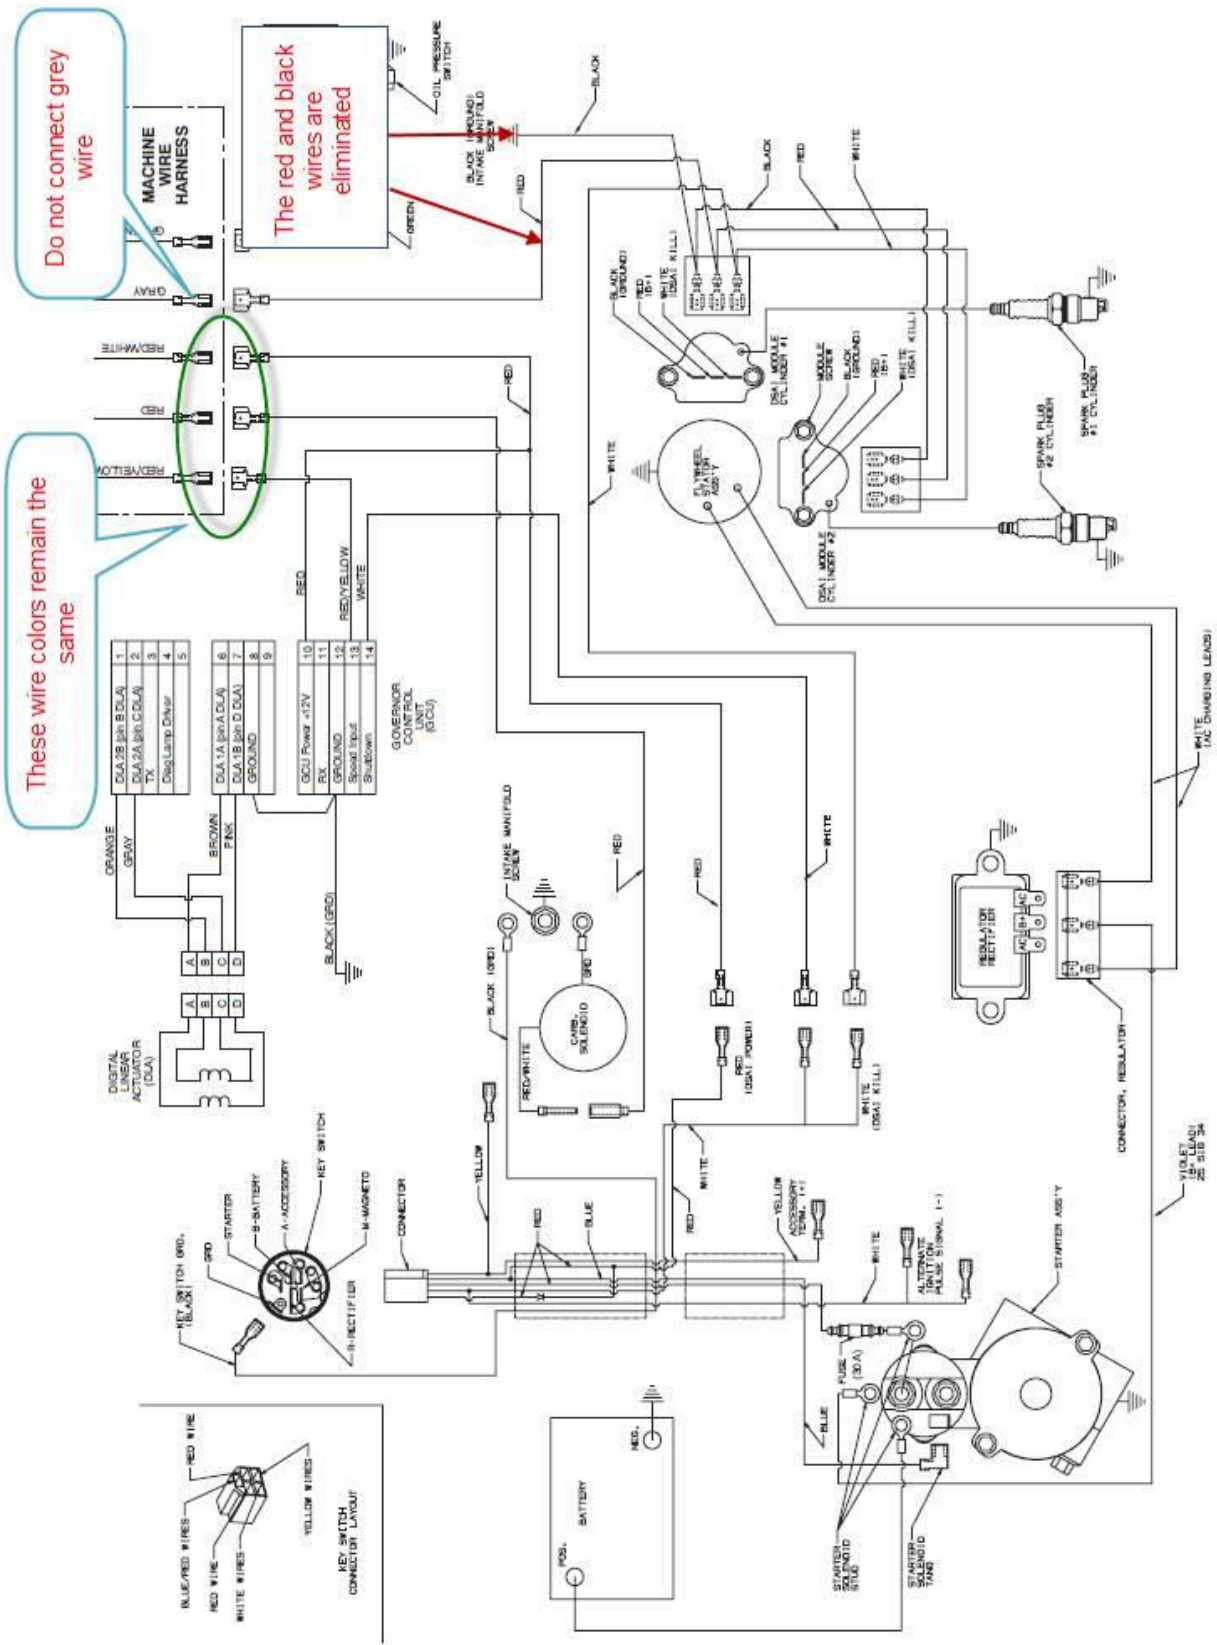
Situation: Replacement Kohler engines for early Pro Force Blowers have different wiring than the original equipment. Kohler has changed their ignition coil from a three wire to a single wire design. This change eliminates the need to connect the grey wire in the Toro harness that originally provided twelve volts to the ignition coil via the red Kohler wire.

Instructions: When installing a new engine, use a schematic to ensure the wires from the from the Toro harness are connected to the correct wires on the Kohler harness. Do not connect the grey wire on the Toro harness to any connectors on the Kohler harness. Connect the single white wire from the ignition coil to one of the available white wire terminals on the Kohler harness. Electrical schematics are located in the back of the operator's manual and the Pro Force service manual.
