**Customer Service
Bulletin
Commercial Business Group**

Seat Maintenance and Safety

Subject: Routine Inspection and Maintenance of Equipment Seats

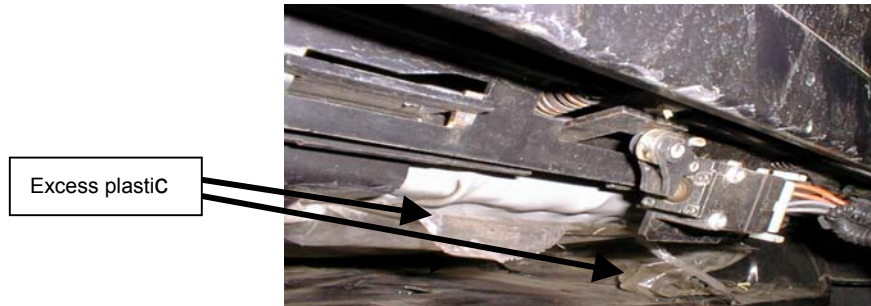
Seats are delivered with a plastic cover for shipping protection. Sometimes a seat may not have this plastic completely removed before use, leaving excess plastic in and around the seat and switch (as shown in the picture below). This excess plastic can dislodge and get caught in the switch and cause it to become inoperative. Debris such as rags, trash, or gloves should not be left around the seat for similar reasons.

It may be easier to remove the shipping plastic from under the seat by lifting out the bottom seat cushion. Remove the seat pad by using the seat pad clips located at the front of the seat, (clip areas are shown on the seat assembly diagram). If for some reason the seat pad cannot be removed, use a tool such as long pliers to remove all loose plastic left on the seat.

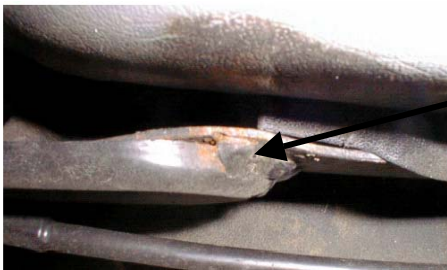
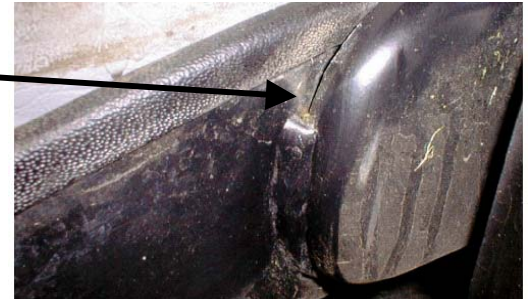
If the seat base becomes damaged in any way, the damaged components need to be replaced, not repaired. This insures proper alignment of seat and backrest assembly. This is extremely important for proper alignment and operation of the seat switch.

A weld type repair can prevent correct seat alignment and switch movement

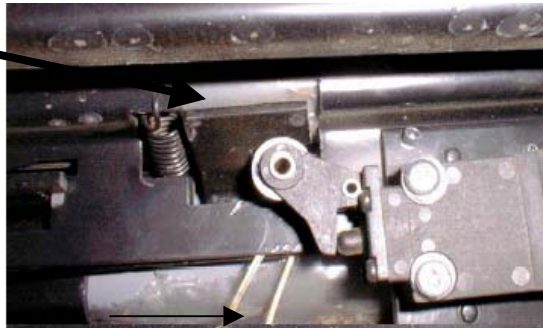
Swing Arm

Even though the seat switch in the picture below looks functional, because the seat had a broken seat frame that was re-welded, the switch swing arm has minimal movement. Due to that improper movement of the mechanism, the seat switch could be rendered inoperable.

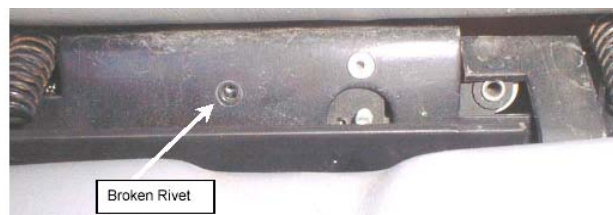
Shown below is the front side of the broken rivet. To inspect this area, push the seat cushion down where the backrest and seating area meet.
