# Customer Bulletin

## Toro Software Update — Rework

Groundsmaster 4000, 4100, 4500, 4700, and 5900 Series

### Safety Alert

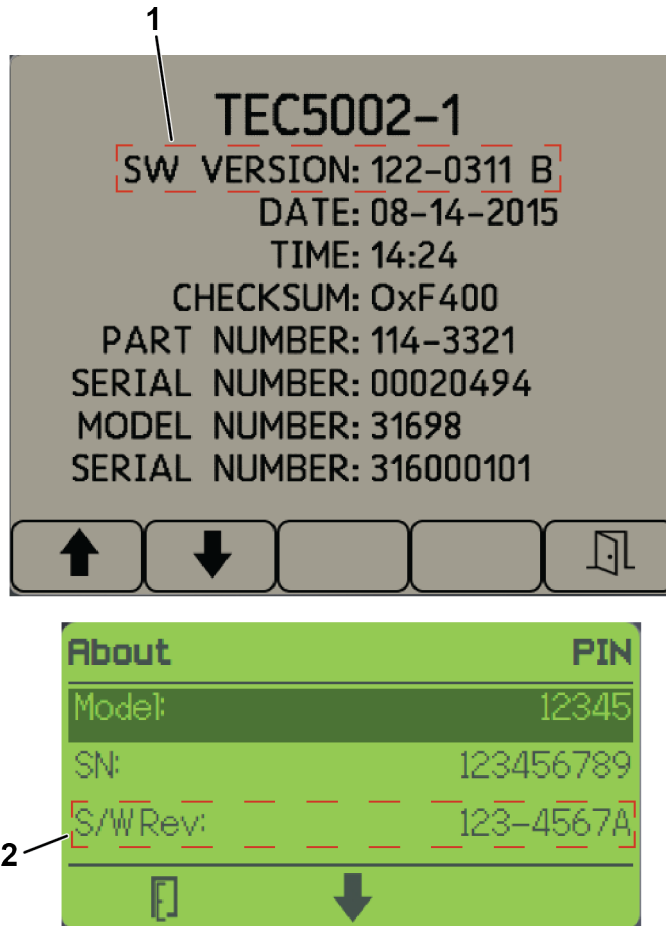
6. Use the machine InfoCenter to check the current software revision level.  
The S/W VERSION (5-button InfoCenter) or S/W REV (3-button InfoCenter) item in the ABOUT menu lists the current software revision level:

1. Software version (5-button InfoCenter)      2. Software version (3-button InfoCenter)
