Customer Service Bulletin
Commercial Business Group

Workman® Sprayer Sonic Boom

Model/Serial Range:	Model Number:	Serial Numbers:
	41036	not applicable

Subject: **Change to Sonic Boom Wire Harness.**

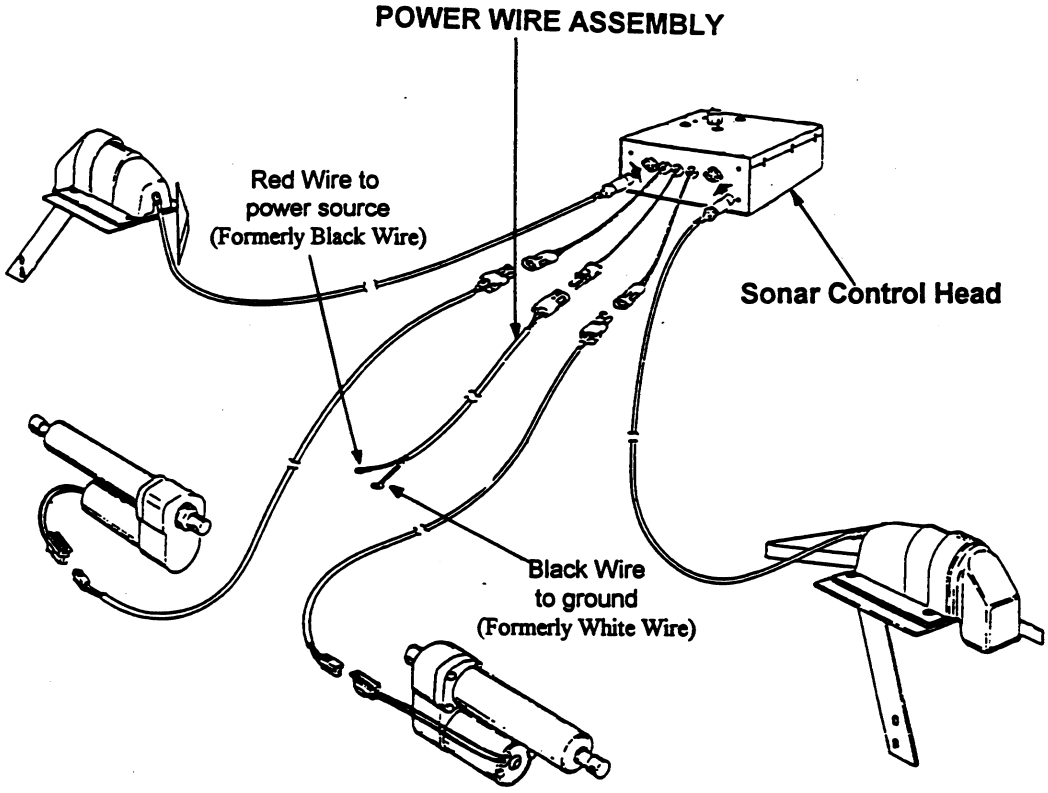
The colors of the Power Assembly leads changed during the 1993 model year. Originally, the power wire assembly used a Black wire and a White wire. The wires were routed as follows:

Black Wire: To the Power Source
White Wire: To Ground

The power wire assembly currently uses a Red wire and a Black wire. The NEW wires are routed as follows:

Red Wire: To the Power Source
Black Wire: To Ground

All current manuals for the 1993 model year are correct in showing the new Red/Black power wire assembly. The power wires regardless of the color of the harness are tagged with an "+" or "-" to ensure proper installation. See illustration below.
