Customer Service Bulletin

Greensmaster[®] 3, 300, 3000, 3050, 3100, and 3200

Subject: Ball Joint Receiver (94-2959) Retainer Sleeve Repair

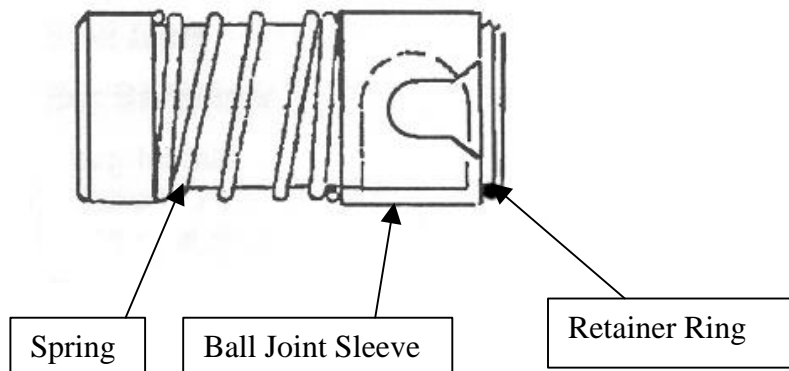
The Ball Joint Receiver has a spring loaded Ball Joint Sleeve (99-1461) that retains the Ball Stud on the cutting unit or accessory. The Sleeve may wear or bend allowing the Ball Stud to disconnect. Should this occur, the Ball Joint Sleeve (99-1461) can now be replaced without replacing the complete Ball Joint Receiver (94-2959).

To replace the Sleeve, remove the Retainer Ring and old Sleeve. Install the new Sleeve and re-install the Retainer Ring.
