Customer Service Bulletin Commercial Business Group

Reelmaster® 3100-D Product

Subject: Slope Angle Indicator (100-4917) - Rework

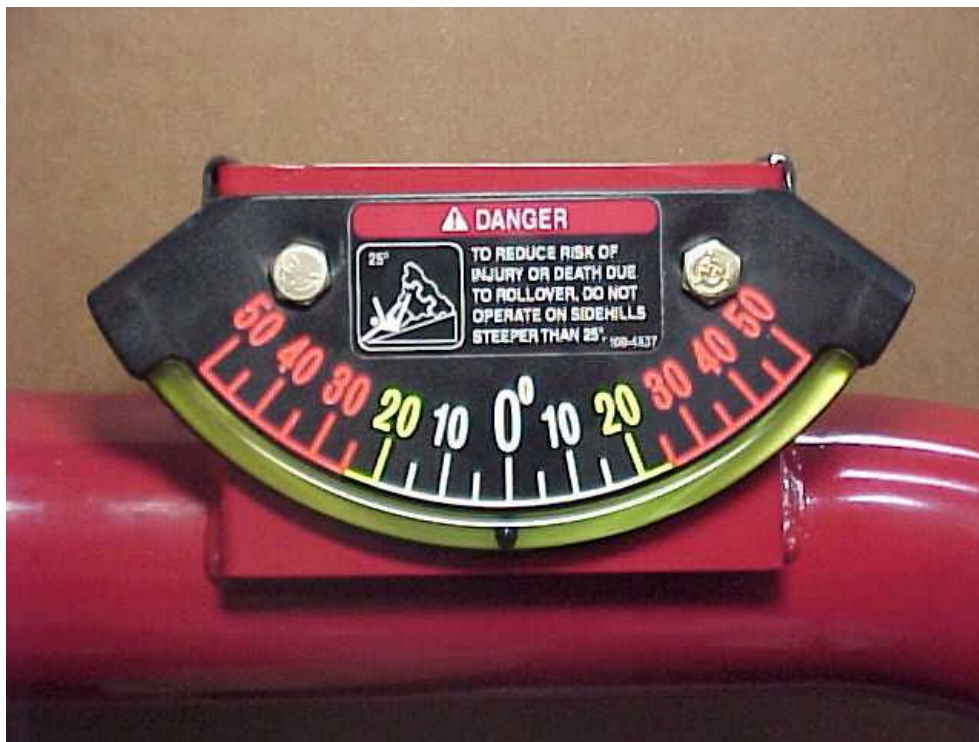
All Reelmaster 3100-D products listed above will be reworked by having a Slope Angle Indicator installed on the Steering Tube to increase the Operator's awareness of the terrain. See sample of Slope Indicator below. Additionally, customers will receive information from Distributor Sales Personnel regarding appropriate safety precautions and operating procedures.
